## RAPID RESPONSE OF A SAND-DOMINATED RIVER TO INSTALLATION AND REMOVAL OF A TEMPORARY RUN-OF-THE-RIVER DAM

K. H. COSTIGAN<sup>a,b\*,†</sup>, C. M. RUFFING<sup>a</sup>, J. S. PERKIN<sup>c,d</sup> AND M. D. DANIELS<sup>a,e</sup><sup>a</sup> Department of Geography, Kansas State University, Manhattan, Kansas, USA<sup>b</sup> School of Environment and Natural Resources, Ohio Agricultural Research and Development Center, The Ohio State University, Wooster, Ohio, USA<sup>c</sup> Division of Biology, Kansas State University, Manhattan, Kansas, USA<sup>d</sup> Department of Biology, Tennessee Technological University, Cookeville, Tennessee, USA<sup>e</sup> Stroud Water Research Center, Avondale, Pennsylvania, USA

Run-of-the-river dams (RORDs) comprise the vast majority of dams on river systems and are commonly removed as a part of stream restoration strategies. Although these dams are routinely removed, few studies have documented the geomorphological responses of sand-bed rivers to the removal of RORDs. We examined the response of a large sand-bed river located in South-Central Kansas, USA, to the installation and removal of a dam that is installed annually for seasonal recreational pu

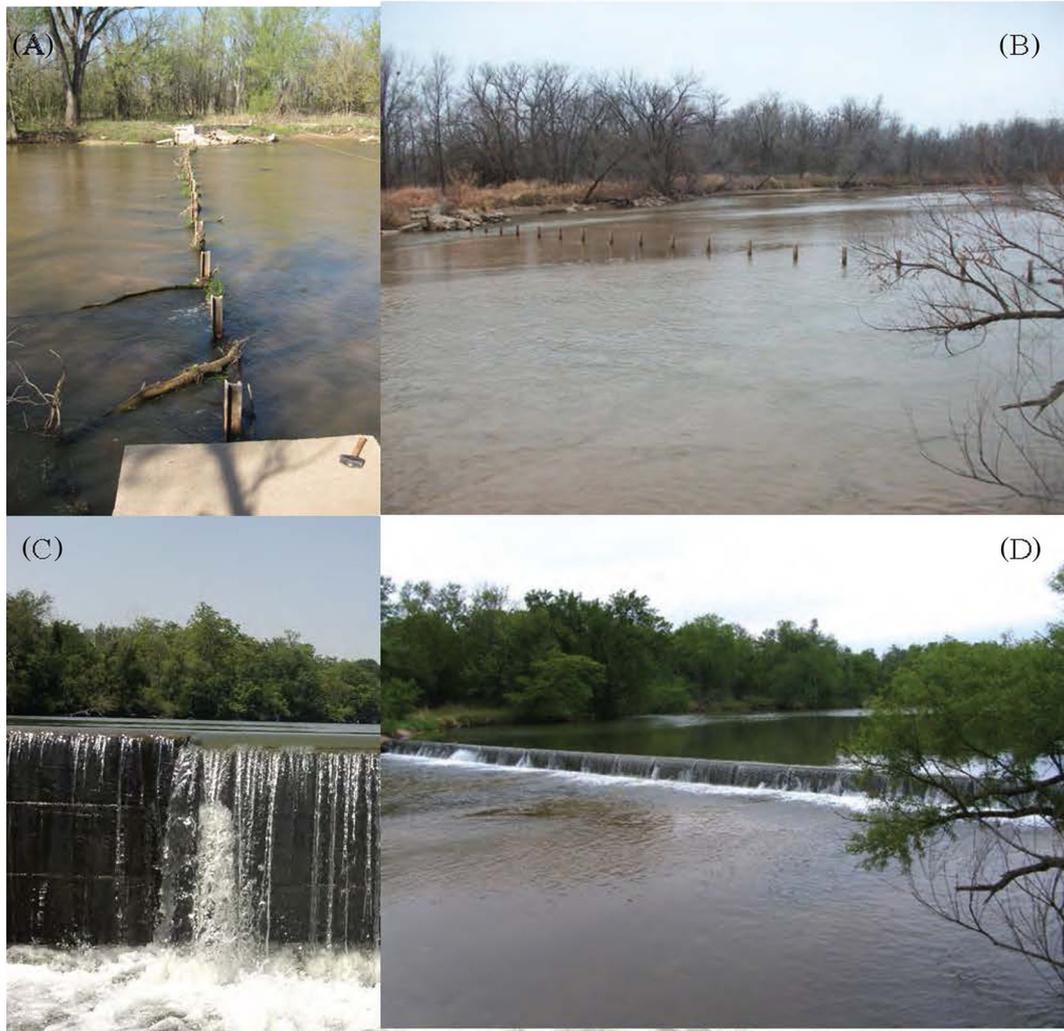
Figure 3. Photographs of the (A and B) permanent I-beams that are in the channel year round that provide foundation for the dam, (C) the installed dam with planks of wood until the dam is 1 m in height and (C and D) of the dam spanning the entire channel width. Photographs (B) and (D) were taken from the same vantage point. This figure is available in colour online at [wileyonlinelibrary.com/journal/trra](http://wileyonlinelibrary.com/journal/trra)

The CMD is a 1-m-high dam that is installed annually for seasonal recreational purposes associated with Camp Mennohcah (e.g. canoeing and swimming) and is in place from April through October. There are permanent I-beams fixed to the bedrock approximately every meter across the width of the river (Figure 3A and B). Wood planks are placed horizontally between the I-beams and added in layers until the dam is 1 m in height (Figure 3C and D). The dam was installed on 4 April 2012 and was removed on 7 October 2012. Because the dam has been added and removed from the river annually for at least fifty years, we use 'installation' rather than 'construction' to capture its transient nature.

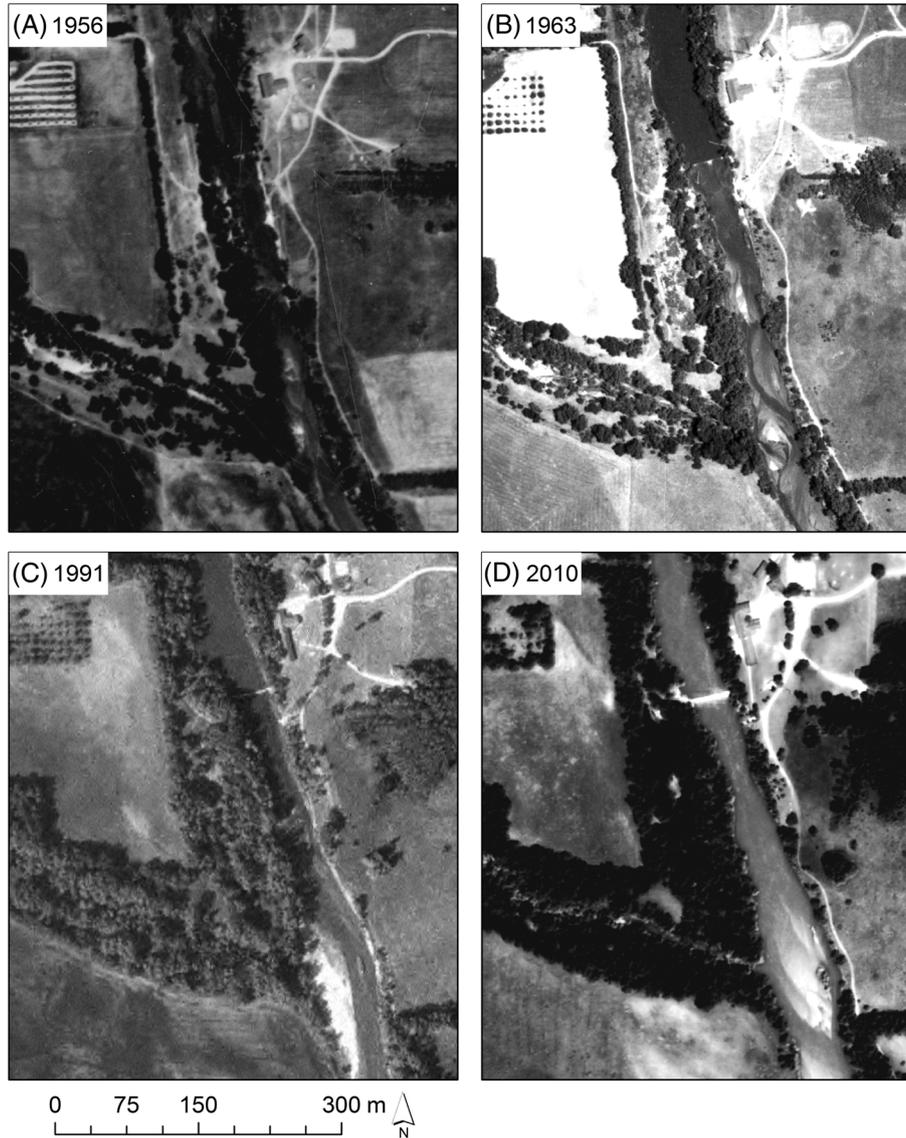
Figure 4. Aerial photographs of the South Fork Ninescah River at Camp Mennoscah Dam between 1956 and 2010

Access and Support Center. The earliest available images of the SFNR within the proximity of the CMD are from 1956 and show that the I-beams were in the channel at this time (Figure 4). The aerial photographs show there have not been any large changes in the channel morphodynamics (i.e. no avulsions) of the river during this period (Figure 4).
